LIMITED ASBESTOS BUILDING INSPECTION

3705 Windflower Cir
Colorado Springs, CO 80918

ATTACHMENT A
Building Floor Plan with ACM locations

LIMITED ABI DRAWING

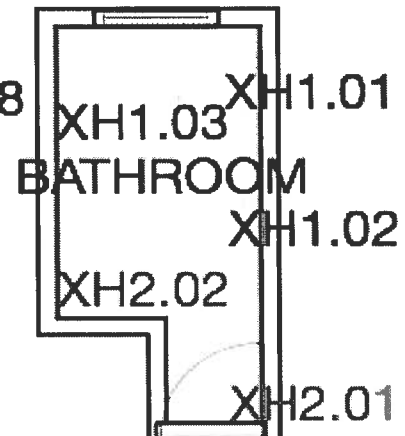
FIRST FLOOR

Joint compound and drywall in the main floor bathroom of the property (Misc)

Bulk sampling conducted during this inspection identified that the joint compound and drywall in the main floor bathroom of the property contains asbestos (2-3% Chrysotile).

Assessment: This inspection identified the material as undamaged and friable at the time of the inspection and had a hazard assessment of "Asbestos Containing Building Material (ACBM) with high potential for damage". This assessment was assigned to the material because of the planned renovation taking place and the close proximity to workers and or occupants. There is an unknown amount of joint compound and drywall in the main floor bathroom of the property. This material was composited and is below the EPA and State of Colorado regulated limit of 1%, however, OSHA guidelines and regulations still apply to this material.

Please Note: CES recommends all renovation work impacting ACM in the building be completed by an EPA certified and Colorado State licensed General Abatement

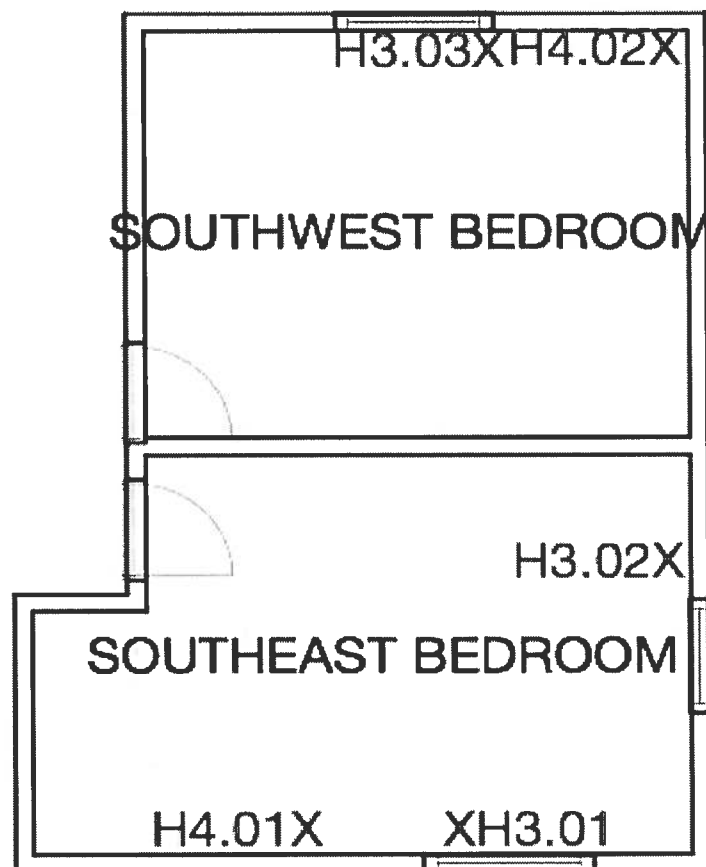
BASEMENT

Wall and ceiling texture in the southeast and southwest basement bedrooms of the property (Surf)

Bulk sampling conducted during this inspection identified that the wall and ceiling texture in the southeast and southwest basement bedrooms of the property contains asbestos (2-3% Chrysotile).

Assessment: This inspection identified the material as undamaged and friable at the time of the inspection and had a hazard assessment of "Asbestos Containing Building Material (ACBM) with high potential for damage". This assessment was assigned to the material because of the planned renovation taking place and the close proximity to workers and or occupants. There is under a 1000 square feet of wall and ceiling texture in the southeast and southwest basement bedrooms of the property being disturbed.

Joint compound and drywall in the southeast and southwest basement bedrooms of the property (Misc)

Bulk sampling conducted during this inspection identified that the joint compound and drywall in the southeast and southwest basement bedrooms of the property contains asbestos (2-3% Chrysotile).

Assessment: This inspection identified the material as undamaged and friable at the time of the inspection and had a hazard assessment of "Asbestos Containing Building Material (ACBM) with high potential for damage". This assessment was assigned to the material because of the planned renovation taking place and the close proximity to

workers and or occupants. There is an unknown amount of joint compound and drywall in the southeast and southwest basement bedrooms of the property. This material was composited and is below the EPA and State of Colorado regulated limit of 1%, however, OSHA guidelines and regulations still apply to this material.
